**FURY: A REMOTE UNDERGROUND STORAGE TANK  
INSPECTION/ASSESSMENT SYSTEM**

**USACERL  
Champaign, IL 61826 USA  
1-800/USA-CERL**

**29 June, 1998**

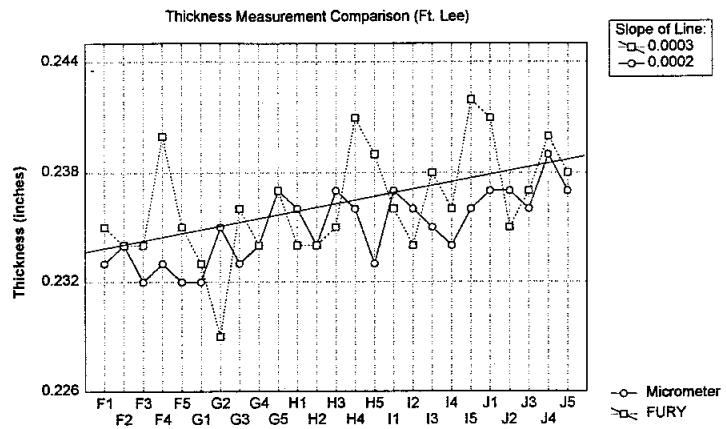
One of the most critical comparisons was that of the Fury in situ ultrasonic thickness measurements to other reference methods. Three 5x5 square grids with 10 cm. spacing were located near the center bottom, one approximately one half the distance to the end cap near the bottom, and one on one end cap. These test grids were marked out with wax pencil and stamp markers. Each measurement location was circled using a vibrating engraver and a robot template positioner. The template was used to assure that in-situ comparison measurements with a hand held ultrasonic thickness gauge were taken from exactly the same position. Both the robot sensor and the hand held thickness gauge were calibrated on the same step block before and after each group of measurements. After the tank was pulled the grids were cut out of the tank, sectioned, and the same measurements were performed using a standard mechanical micrometer capable of an accuracy of 1/1000 of an inch. The in situ Fury and laboratory micrometer measurements are shown in Figures 3 through 5.

Figure 3. Bottom, Middle Mechanical vs. Fury Thickness Measurement

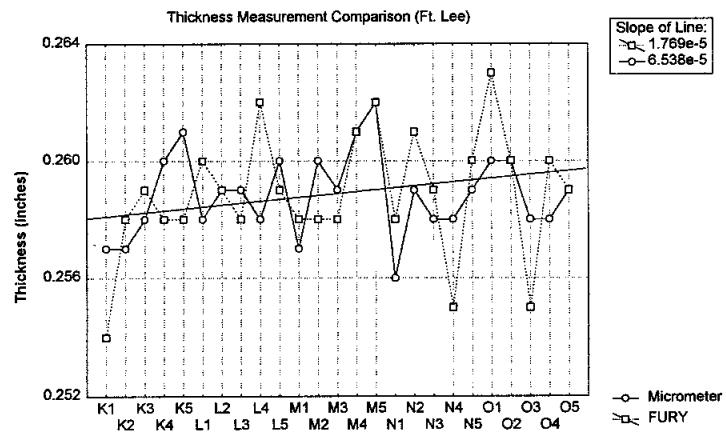
Figure 4. Bottom, Quarter Mechanical vs. Fury Thickness Measurement

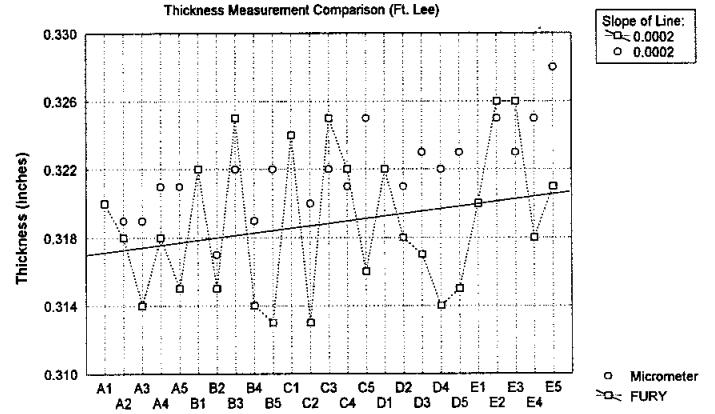
Figure 5. End Cap Mechanical vs. Fury Thickness Measurement

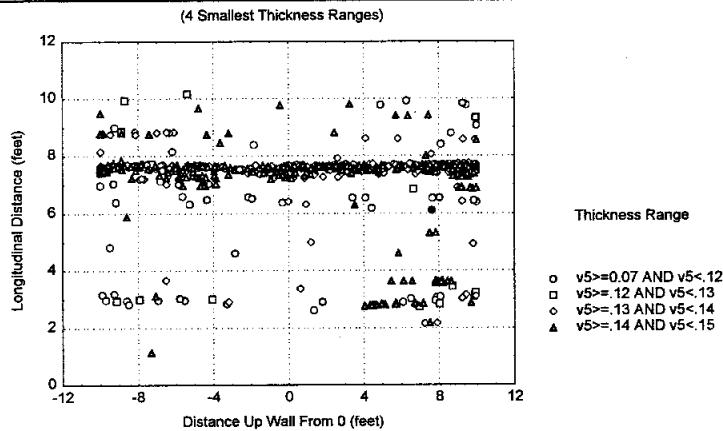
Figure 6. Location Distribution of 1000 Thinnest Wall Thickness Measurements

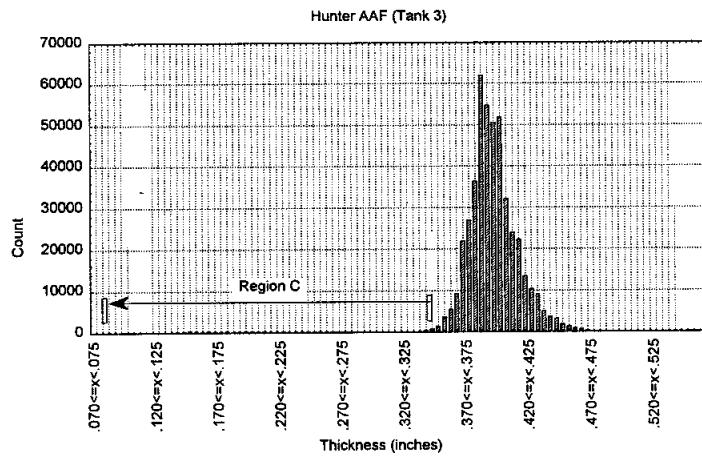
Figure 7. Thickness Distribution in Tank 3

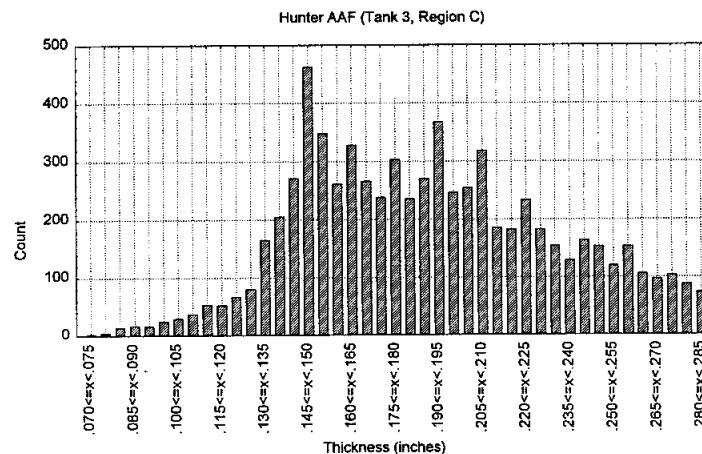
Figure 8. Thickness Distribution Region C in Tank 3 (Figure 5)

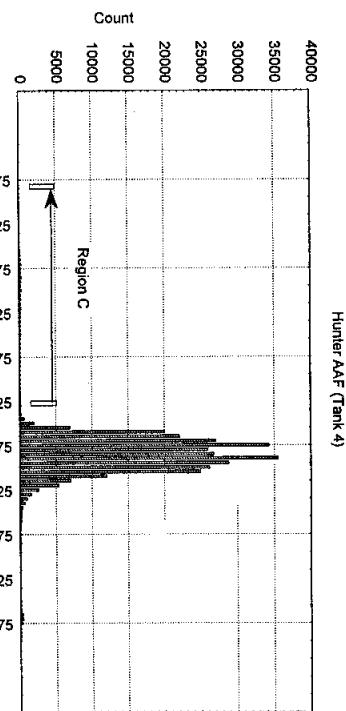
Figure 9. Tank 4 Thickness Distribution

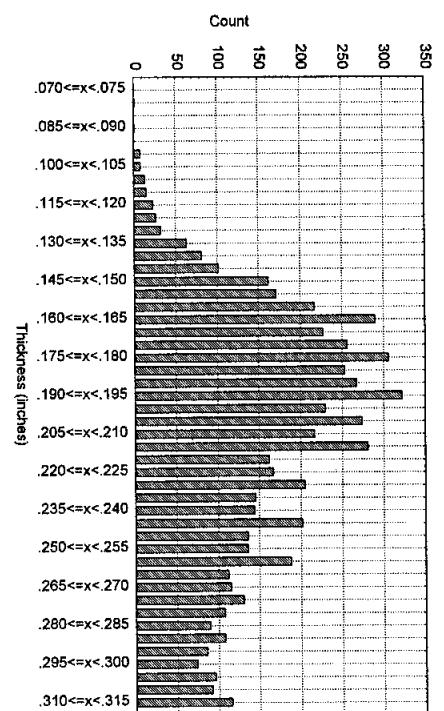
Figure 10. Region C Thickness Distribution in Tank 4 (Figure 7)

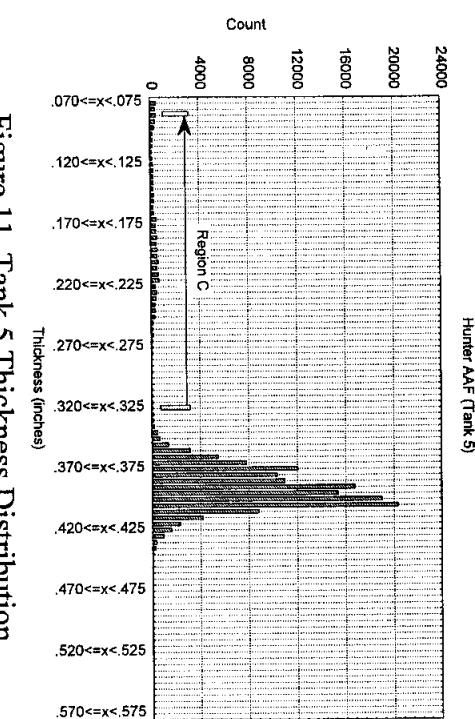
Figure 11. Tank 5 Thickness Distribution

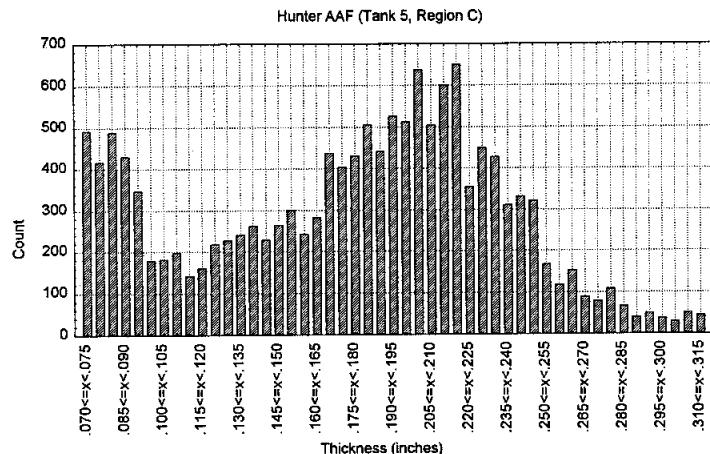
Figure 12. Region C Thickness Distribution Tank 5, (Figure 9)
